ARCHITECTURAL  
CONSERVANCY  
ONTARIO

# ACORN

FALL 2018

## THE CRAFT OF CONSERVATION

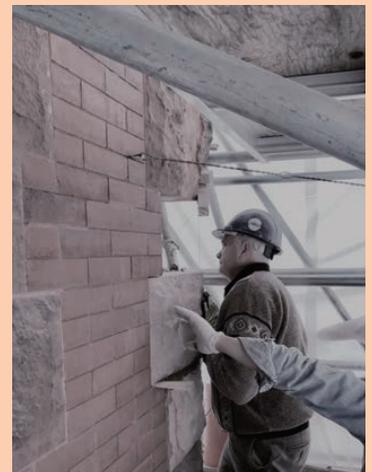
Sandstone restoration at 135 St. George Street, Toronto. **Photo** The York Club, 2018

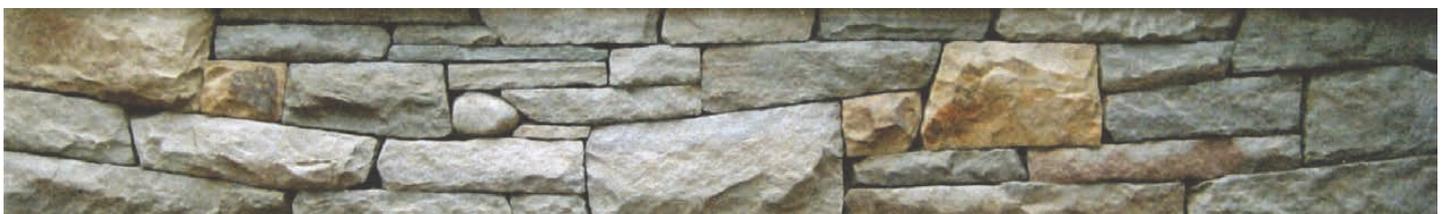
▲ Raewynn's Wall constructed by Augustus Butterfield. Photo Augustus Butterfield, 2009

Let's look more closely at the example below. Although a contemporary wall, it was constructed with knowledge of and references to historic stone construction processes and materials. I see that the proportional relationships of the stone shapes give visual and functional balance, as well as a rhythm to the composition. The dominant horizontal lines are unifying elements; however, as I look carefully, a couple of those lines are almost diagonal and perhaps even ironic signifiers. While the colours and tonal values of the stones also move the eye around the composition of the wall, there is contrast in the texture and a few of the stones are trapezoidal. Could this wall have a dynamic composition instead of the common homogeneous coursing? Indeed, as the viewer's eye follows the subtle variations of the negative spaces

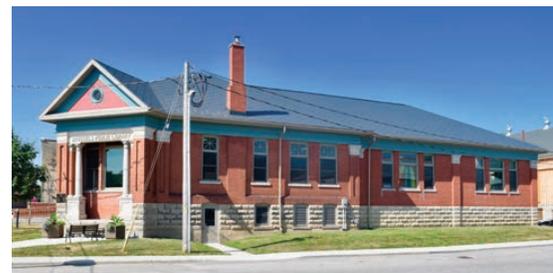
▲ The 1910 corner pediment of Brussels Library on the left with 2015 addition on the right. Photo Dan Schneider, 2018

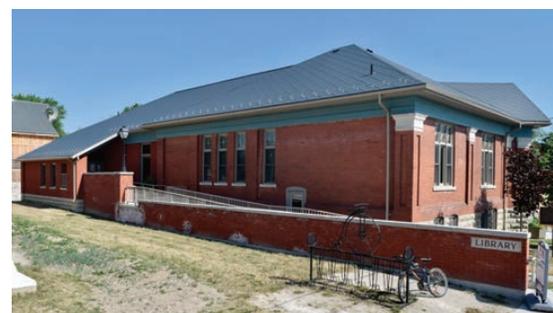
▲ The new ramped entrance creates a brick base for the original building. Photo Dan Schneider, 2018

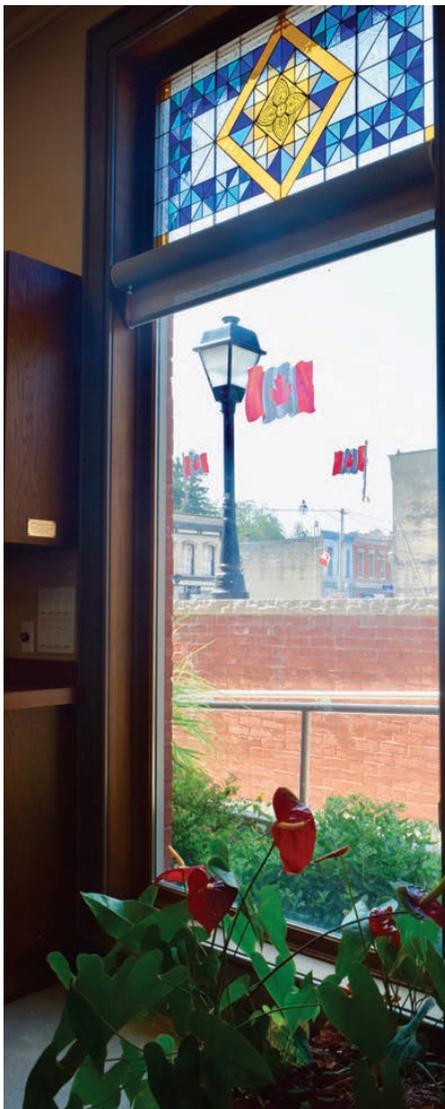
◀ New windows in the addition are variations of the original windows. **Photo** Dan Schneider, 2018

unsuccessful attempts at various window types, shapes, sizes, and arrangements, I realized the original architectural vocabulary was not what I had thought. In reality, the original windows are variations of the same double-hung window, each topped with a single or double “spider” transom window. What seems to be a regular, symmetrical repetition of identical elements is

actually an irregular composition that only implies regularity. Designing more variations of the existing original window configurations and placing them irregularly around the new addition’s exterior with an informal relationship to the addition’s interior rooms, I slowly realized an architecturally sympathetic design for the building’s addition was emerging with its own vocabulary — one that had grown out of careful analysis of the original architecture. Kolbe brand wood-framed windows with pre-finished exterior metal cladding were used for authenticity, low maintenance, and increased energy efficiency.

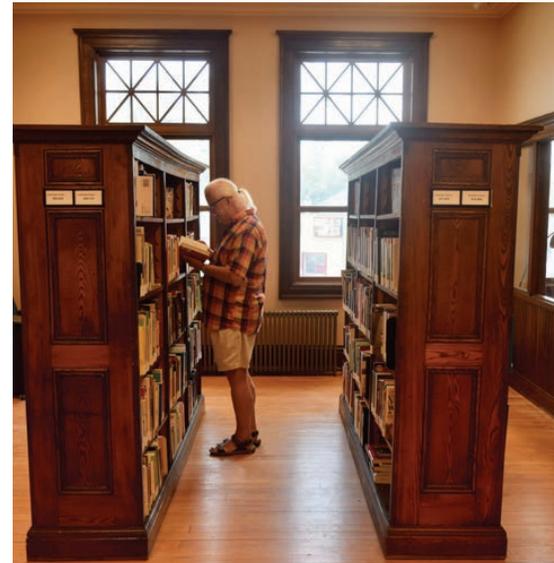
▲ Replacement windows with “spider” transoms and relocated original bookcases help to restore the original interior. **Photo** Dan Schneider, 2018

During the 1970s the ceiling was dropped to potentially make the building easier to heat. The original transom windows above the double-hung windows were boarded up to accommodate the lowered ceiling. This previous renovation decreased natural light levels in the building. The public was happy when we raised the ceiling back up to almost its original height, with additional insulation, and reinstated the windows with their "spider" transoms. Maintaining the building's original interior glazed partitions, woodwork, ceiling height, windows, and transoms preserved and

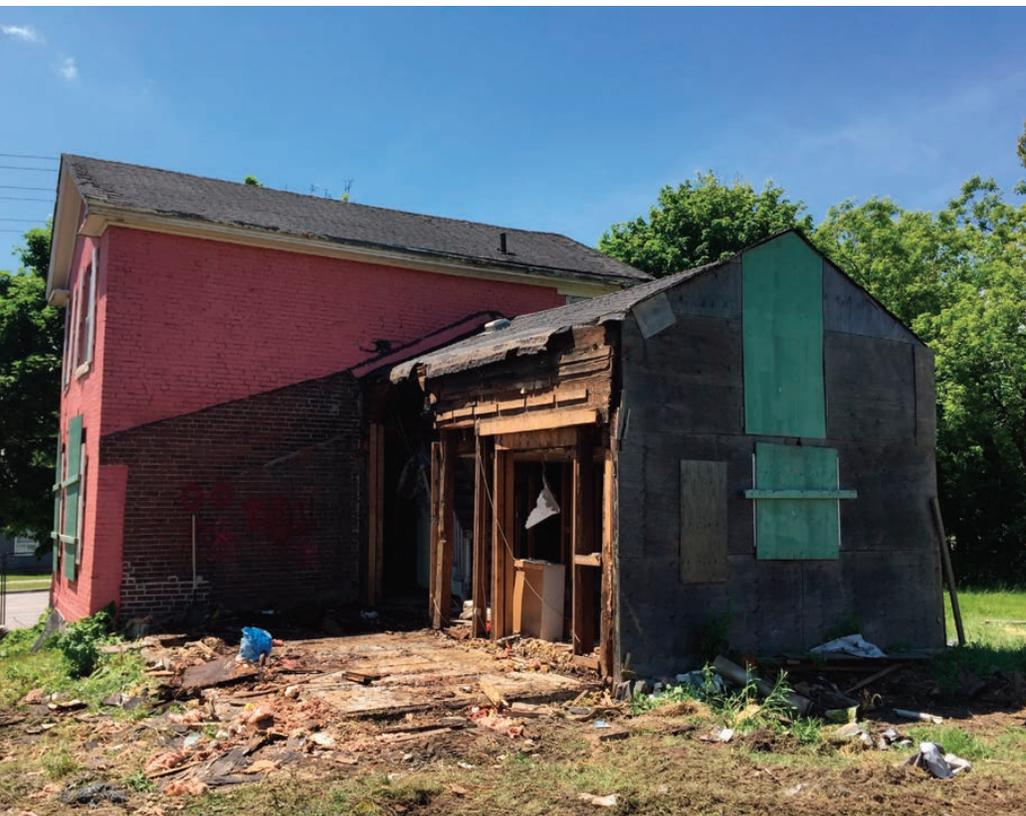
▲ Original pre-1840 wood-framed structure attached to 1840 brick building in Whitby. Photo Paul Goldsmith, 2016

The building, known as the Abner Nash House, was built in 1840 in brick and had a wood-framed back "addition." The property was once owned by the Scadding family and prior to that by John Graves Simcoe. A dilapidated and more recent lean-to porch and much debris in the interior obscured the character of the so-called back addition; however, careful inspection determined without doubt that the wood structure described as a back addition was, in fact, the original structure and the 1840 brick building was the later front addition.

It was the geometry and modest size of the older back building that first suggested a different story. Measuring just 5 metres by 6.5 metres (16 by 22 feet), it had a one-and-a-half storey timber-framed structure, just a step up from grade to the ground floor, on a foundation separate from the attached 1840 building. It was several steps up from there to the ground floor of the front brick house and its attic-like second floor had a very low

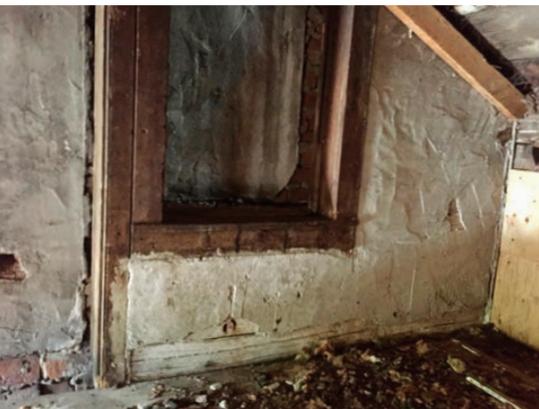
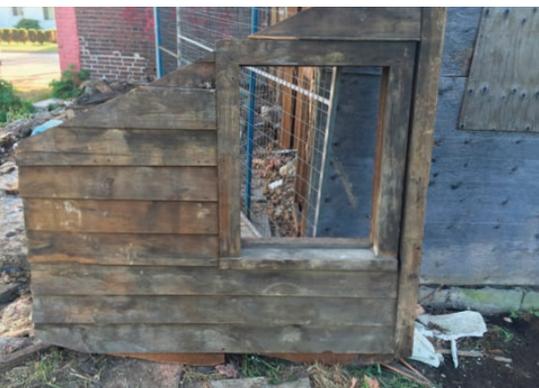
▲ Interior and exterior views of wall facing the 1840 building.  
Photos Paul Goldsmith, 2016

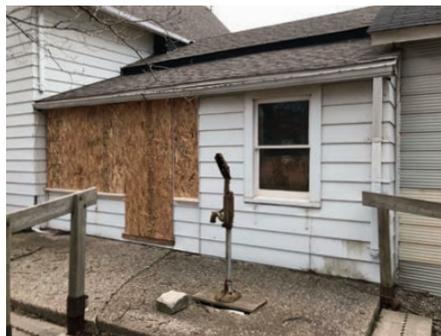
▲ One-storey back kitchen on Old Bronte Road. Photo Paul Goldsmith, 2018

From the site evidence, it was quickly determined that the one-storey back kitchen was the original building on the site and that the 1875 building on the east side and storage area on the west side were later additions. With smaller north and south side additions and alterations, the original structure is now at the center of the building and in good condition.

As with the Whitby building, it was the building geometry that first suggested a different evolutionary sequence. The one-storey middle structure is the only area with a cellar and its stone foundation is clearly independent of the adjoining structures. The wood structure exposed there includes sill plates of heavy adzed timbers and floor joists of round logs, many with bark remaining and cut flat on the top face to accept floor boards.

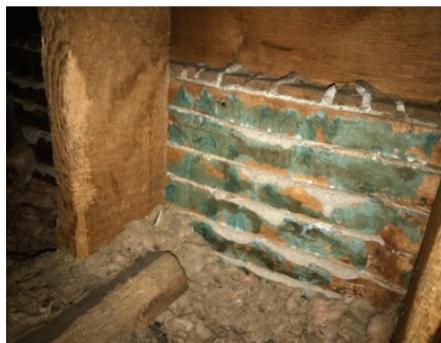
▲ Painted, recycled split lath. Photo Paul Goldsmith 2018

To add to the interest of the building, some of the split plaster lath was made from recycled painted wall panelling. The addition on the south

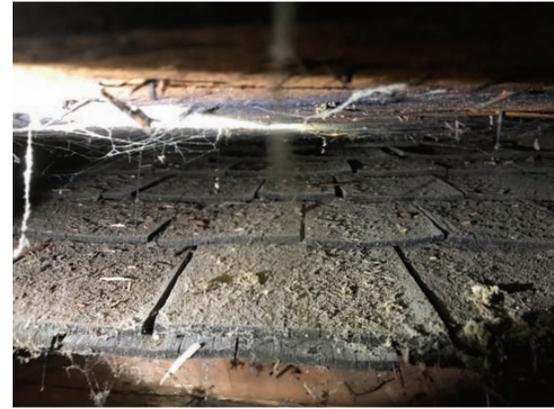
▲ Original cedar roofing enclosed within the attic of the later annex. Photo Paul Goldsmith 2018

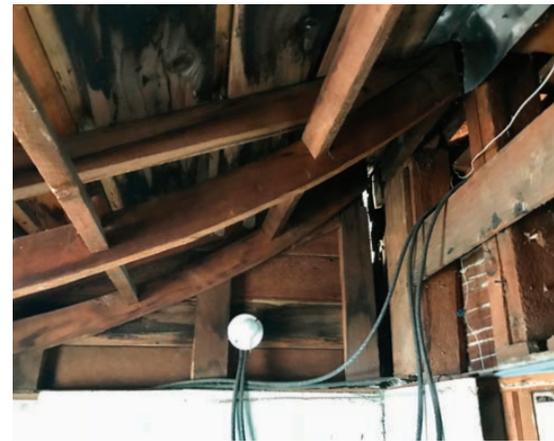
▲ Curved rafters from the porch of the original building. Photo Paul Goldsmith, 2018

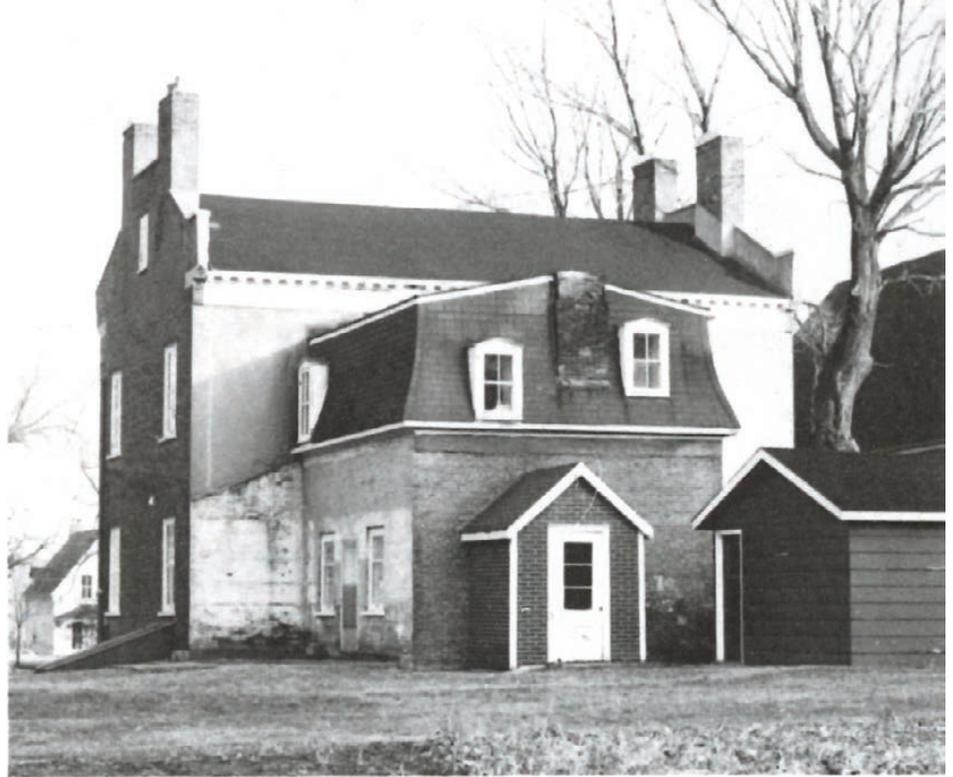
▲ The rear of Washburn House showing an earlier wing on the circa 1835 residence. Photo from *The Settler’s Dream: A Pictorial History of the Older Buildings of Prince Edward County* by Tom Cruikshank and Peter John Stokes.

The circa 1835 Washburn House in Picton had a brick back “addition” that was described by Tom Cruikshank and Peter John Stokes in *The Settler’s Dream: A Pictorial History of the Older Buildings of Prince Edward County* as original, but with a later alteration of a mansard roof to the second storey. During a recent renovation, the age and significance of the back extension was not recognized, possibly because of the late-nineteenth-century Empire Revival Style mansard roof, and approval was given for its replacement by a new addition in a “classical” design. During demolition, it became clear that the addition was

structurally independent of the main house and the ground floor walls were constructed of a small brick without a frog, recognized for their great age by a local engineer expert in heritage structures.

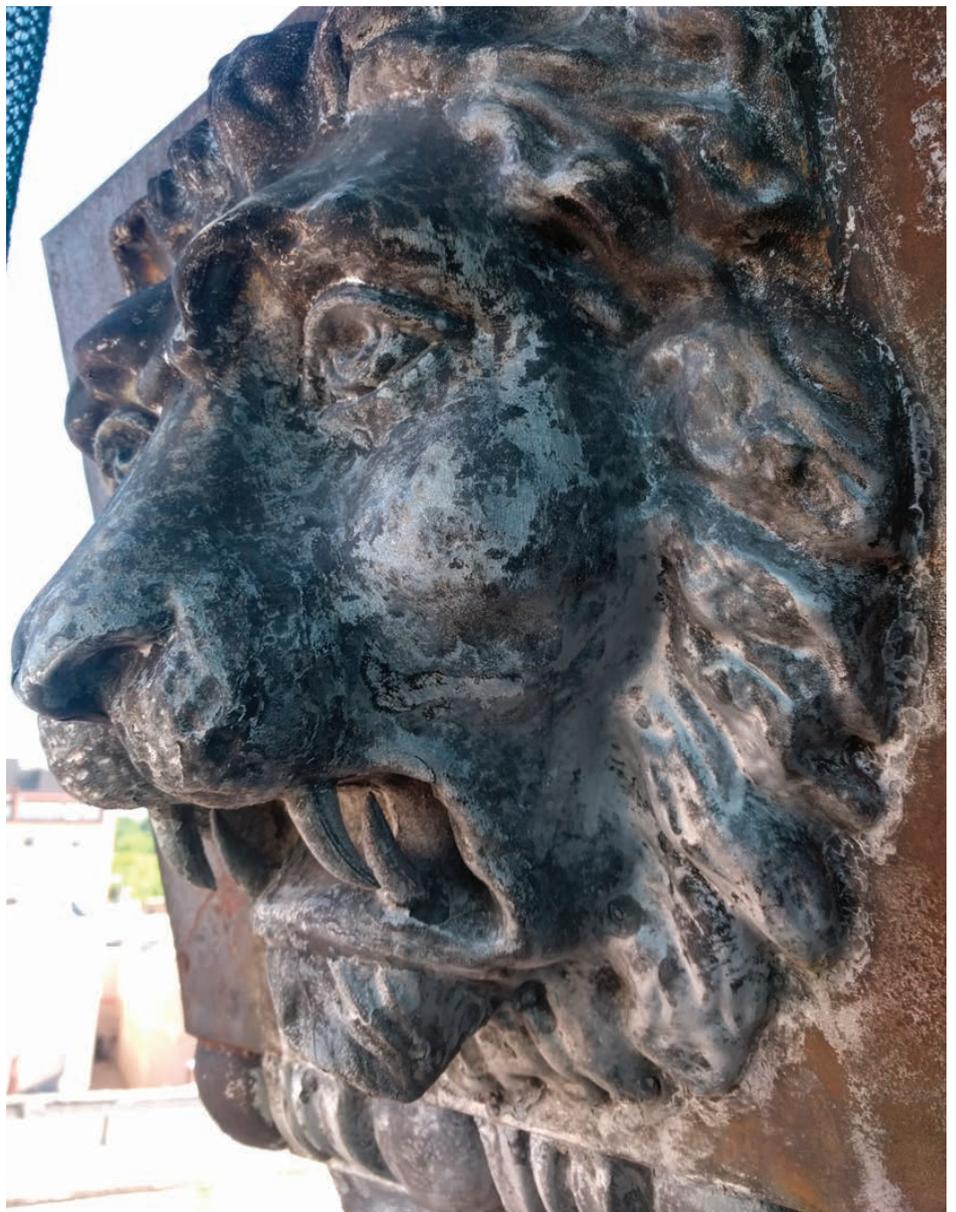
▲ Lion's head sculpture on the Petrie Building, 19 Wyndham Street, Guelph. Photo Alexandre Krucker, 2017

surface. Being up close and personal with certain features, I was awestruck by the details of the corn, the lions and seeing the artistry that went into making them. I found it to be a very intimate relationship working on revitalizing the façade.

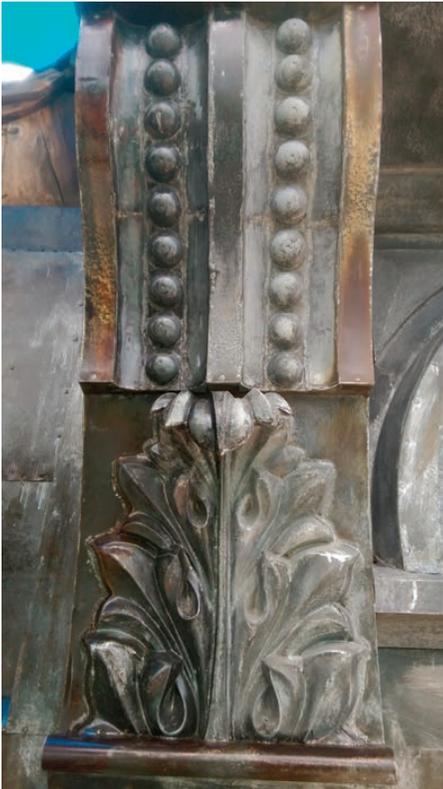
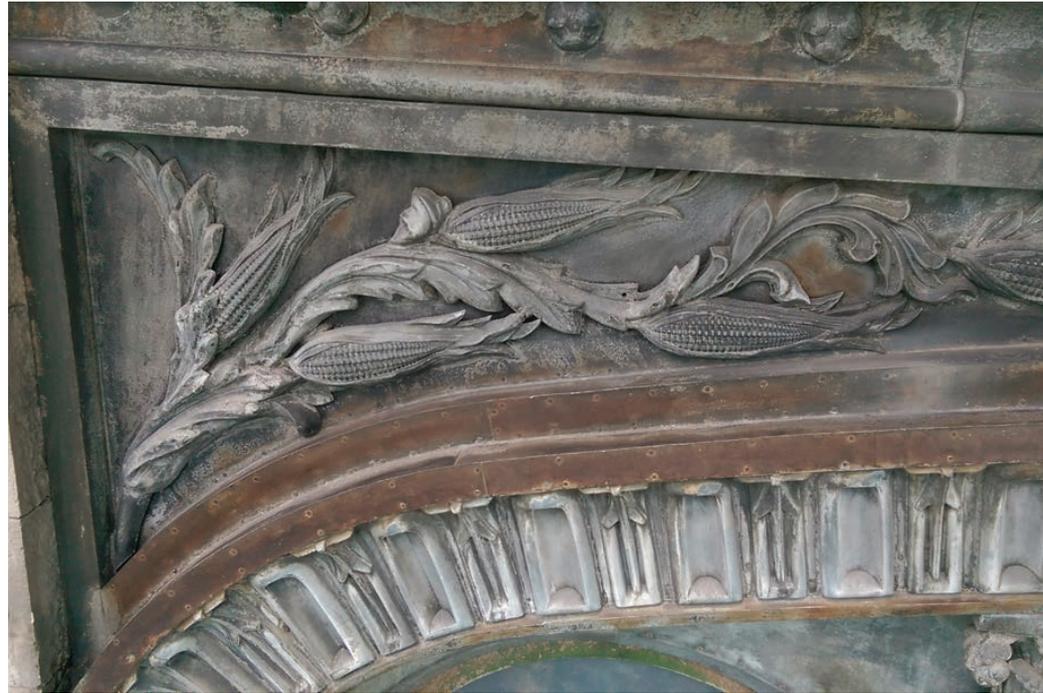
▲ Corn detail on Petrie façade. Photo Christian Tice, 2017

◀ Detail showing ornament before (left) and after cleaning and coating (right). Photo Christian Tice, 2017

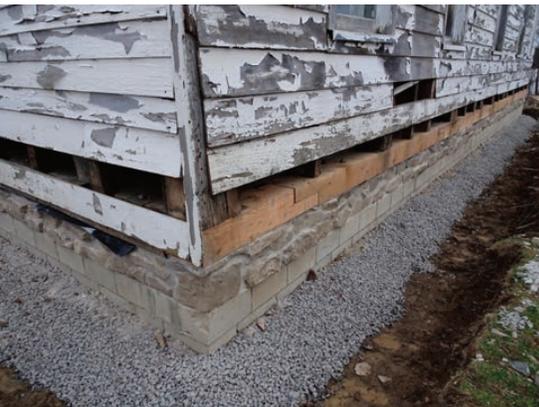
▲ The restored Beaverdams Church foundation following repair in 2017. Photo Courtesy of Mark Shoalts

At Beaverdams Church, Shoalts’ acuity was first demonstrated with the foundation restoration. Recognizing that the structure required stabilization before work could begin, a non-invasive and easily reversible support system was designed and installed by attaching Krinner ground screws to each of the building’s posts<sup>1</sup>. Importantly, the solution did not require excavation and therefore did not disrupt the archaeological strata. After receiving the go-ahead from Archaeological & Cultural Heritage Services in August 2016, Heritage Brick and Stone of Ancaster began work that October.

The first step was to remove the stone foundation and the deteriorated portions of the timber sill — thus leaving the massive 40 by 50 square foot building supported solely by the Krinner screw system. Once the new Douglas fir sills were installed and the structure levelled, a reinforced concrete footing and block foundation was installed prior to facing the whole area above grade with salvaged stone. The work was completed by April 2017.

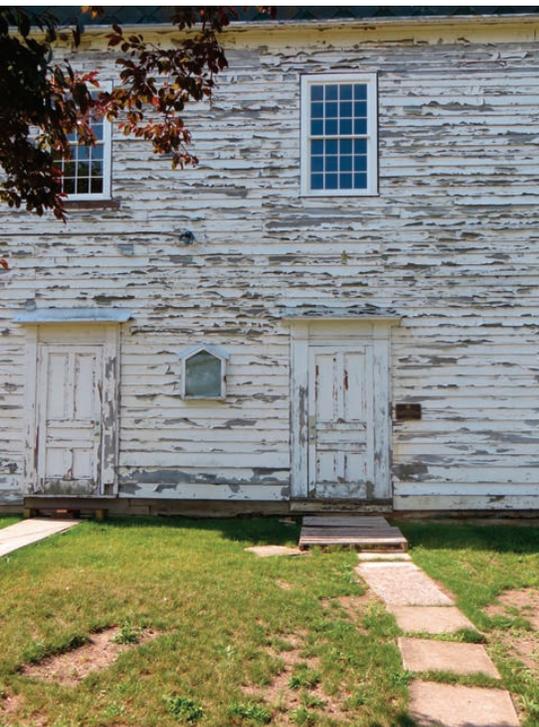
▲ The restored windows in 2018. Photo Sarah King Head

the company does not have a website and recommendations come solely word-of-mouth. From a first meeting in April 2017, it took slightly more than a year to complete the bespoke window order. In addition to emulating the twelve-over-twelve style that would have been used from the time of the church's construction in 1832 until replacement with larger double paned-sashes at the end of the nineteenth century, each pine window relies on a window configuration with beaded stops and stools typical of the pre-1850 period in mostly original frames.

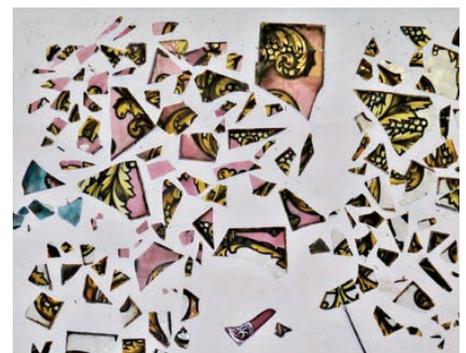
▲ Of the many shards from a damaged laylight, only two small pieces were intact enough to be included in the final piece. Photo John Wilcox, 2016

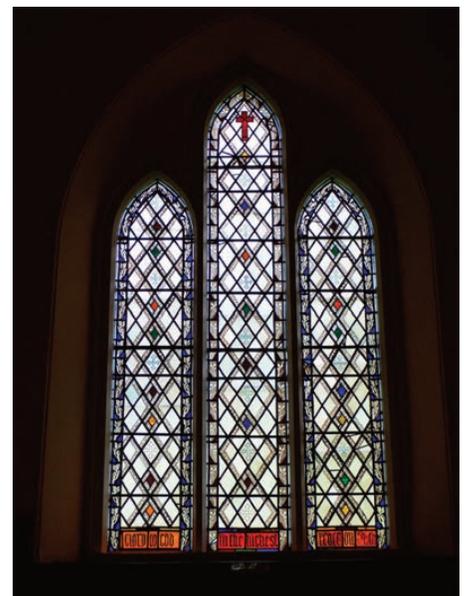
▲ Opaque trace lines of the Simcoe window, St. George's Sibbald Point built 1876-77. Photo John Wilcox, 2011

First to be applied are the trace lines. They are thick opaque brush lines building out the form, blocking light completely. The hand of artisan is evident in the opaque trace lines in what I would like to believe is our first "Canadian" painted leaded glass — a wonderfully lacey grisaille window created by Elizabeth Posthuma Simcoe and her seven daughters. The three-lite east window arrived from England in mid-1830s as tribute to their dear friends back in Upper Canada — the Sibbald family. It was eventually moved from the original

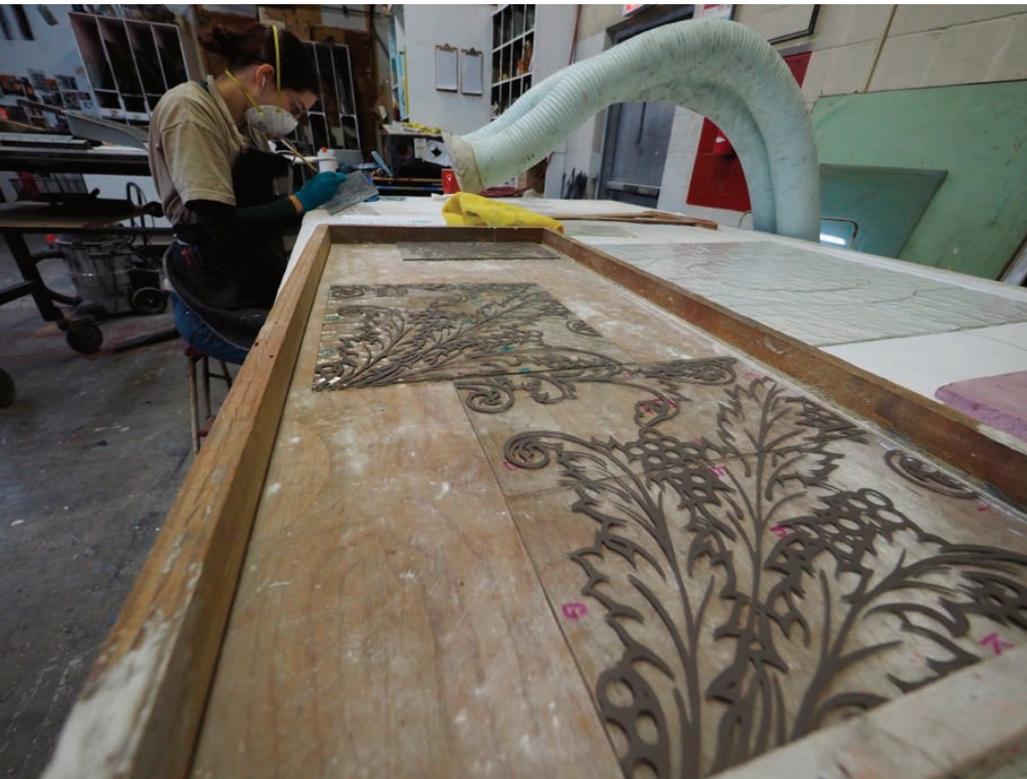
▲ Megan Albinger of vitreous glassworks cleaning trace lines. Photo John Wilcox, 2016

Painting a stained glass window is the reverse of painting on surfaces. Covering our glass with metallic oxides to block the light, our paint creates darknesses to model the light into form. The oxides are mixed with finely ground "soft" glass and, after a controlled firing of about 600°C, the

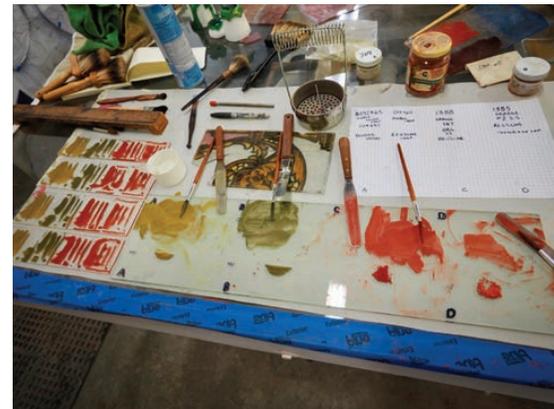
▲ Testing silver stain. Photo John Wilcox, 2017

fit roughly into a timeline of the last 500 years. Prior to this, artisans could only add browns and blacks or reveal underlayers of the coloured glass. Silver stain could now be utilized to produce varying hues from pale straw to golden orange. When applied to blue glass the stain magically transforms into green.

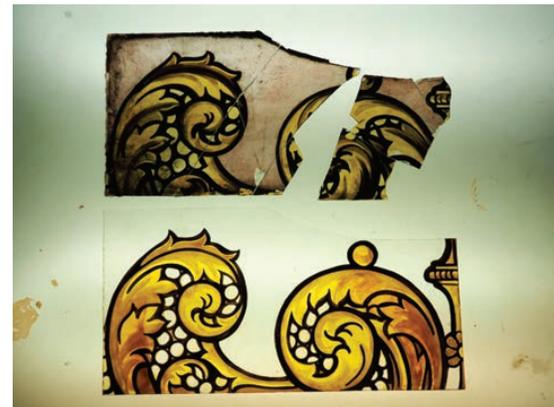
▲ Stain replication. Photo John Wilcox, 2017

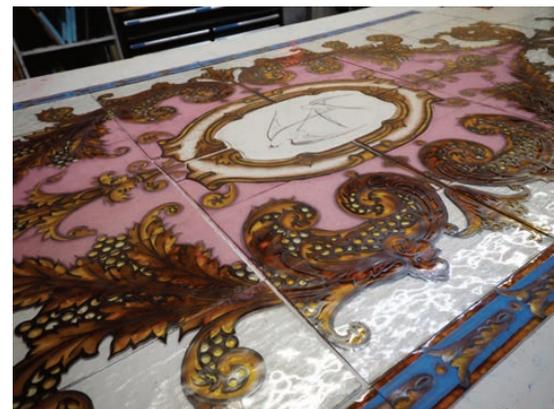
▲ Pink and blue enamels prior to firing. Photo John Wilcox, 2017

The final glass treatment for this particular laylight involved firing coloured enamels. Glass colour is created by melting particular metallic oxides with sand before the melt or batch. Gold creates pink; cobalt creates deep blue; and the ubiquitous iron creates the green hue we are familiar with within our modern "clear" glass. Enamels are a bit of a cheat. Glass enamels are pulverized "soft" coloured glass fired onto the surface of sheet glass. Although they are not as lustrous, true and permanent as batch colour, they do allow the stained glass artisan to add colour within each piece.

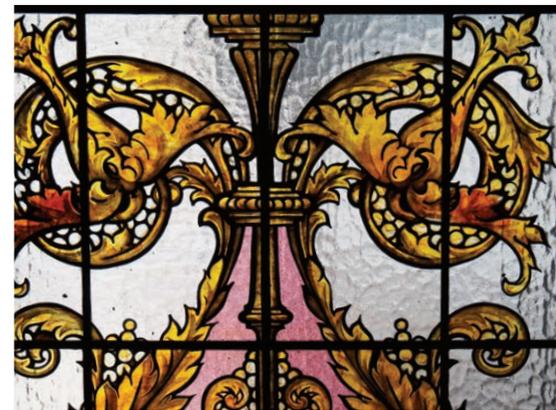
▲ Trace, matte, stain and enamel techniques were combined to create this replica laylight. Photo John Wilcox, 2017

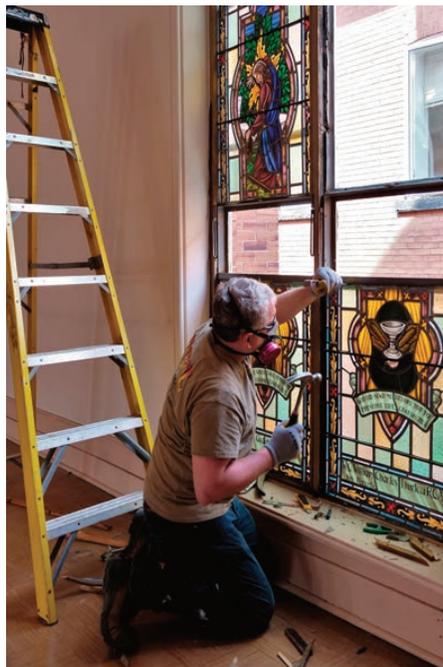
▲ Wearing a respirator and protective gloves, Adam Frazee of Sunrise Stained Glass is using a hammer and chisel to free a section of one of the larger 1950s Luxfer windows.

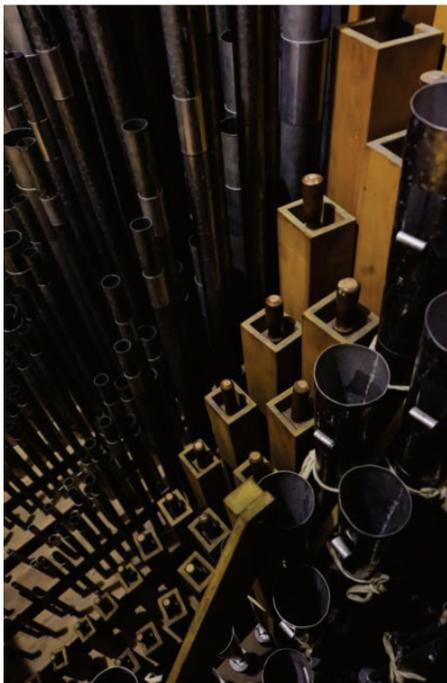
▲ Rank upon rank of pipes – both flues and reeds, metal and wood – were among the hundreds of pipes in the Swell division, one of four pipe divisions in the Trinity organ.

The pipes are a study in beauty all to themselves. Each hand-made in metal or wood, the pipes in the ‘Woodstock’ ranged in size from just over an inch to 16 feet in length. The largest, activated not by the keyboard but by foot pedals, produced the lowest pitched notes and extended down a half storey below the chancel. A full storey down was the original hand-stenciled Woodstock blower, powered by an electric motor.

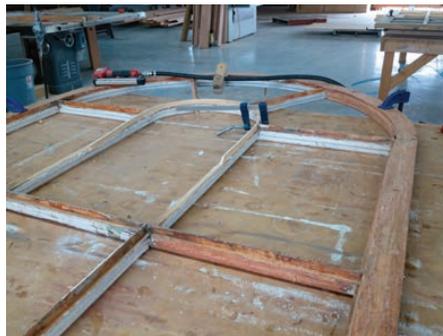
▲ The oldest layer of paint dated to the 1800s. Photo Em Cheng, 2016

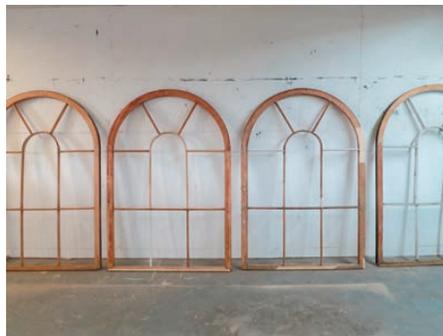
▲ Old growth wood was salvaged and spliced together with new wood using Dutchman repairs. Photo Em Cheng, 2016

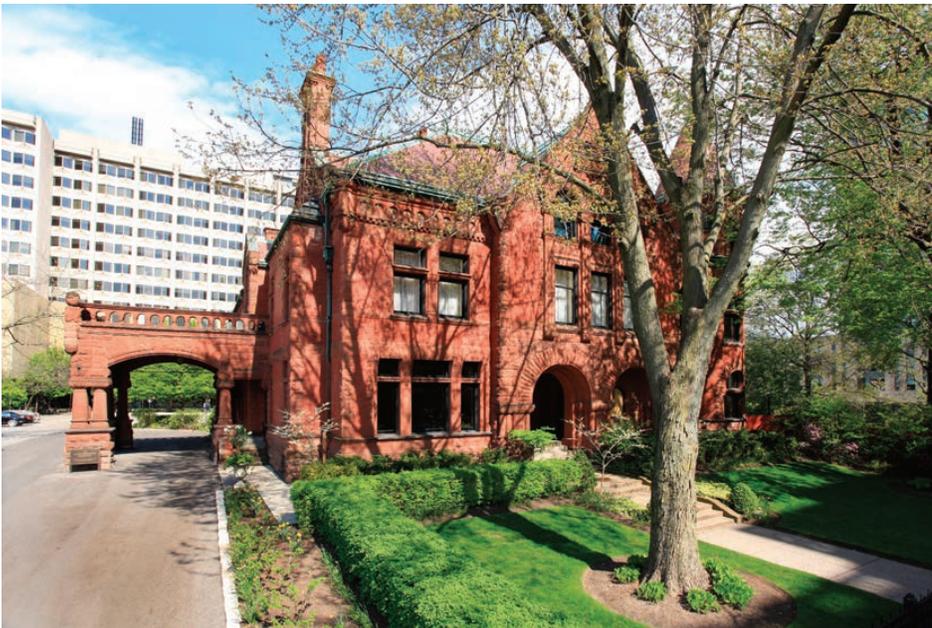
▲ Originally the George Gooderham House, 135 St. George Street in Toronto has been home to The York Club since 1909. The porte cochère prior to restoration. Photo The York Club, 2017

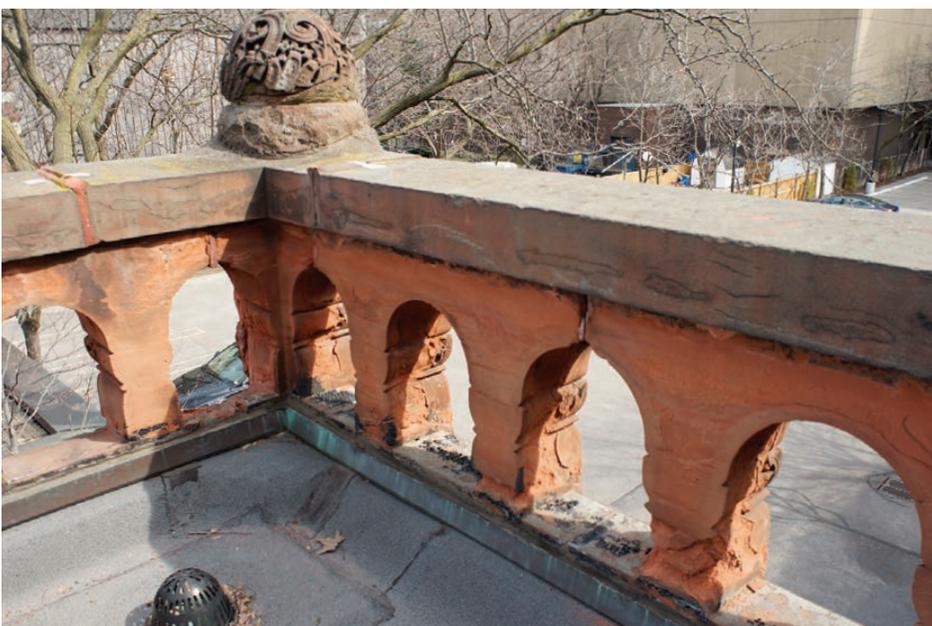
▲ The parapets showing signs of weathering and damage before restoration. Photo Spencer Higgins Architect, 2017

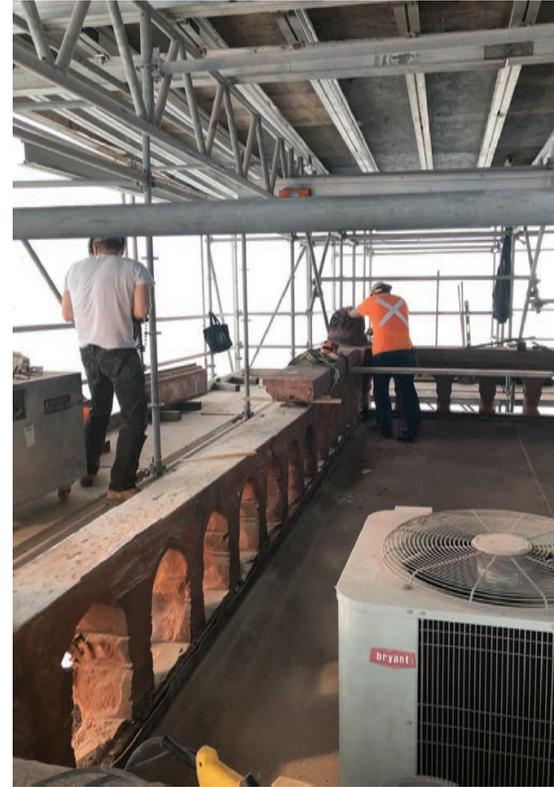
▲ Careful removal of damaged stonework. Photo The York Club, 2018

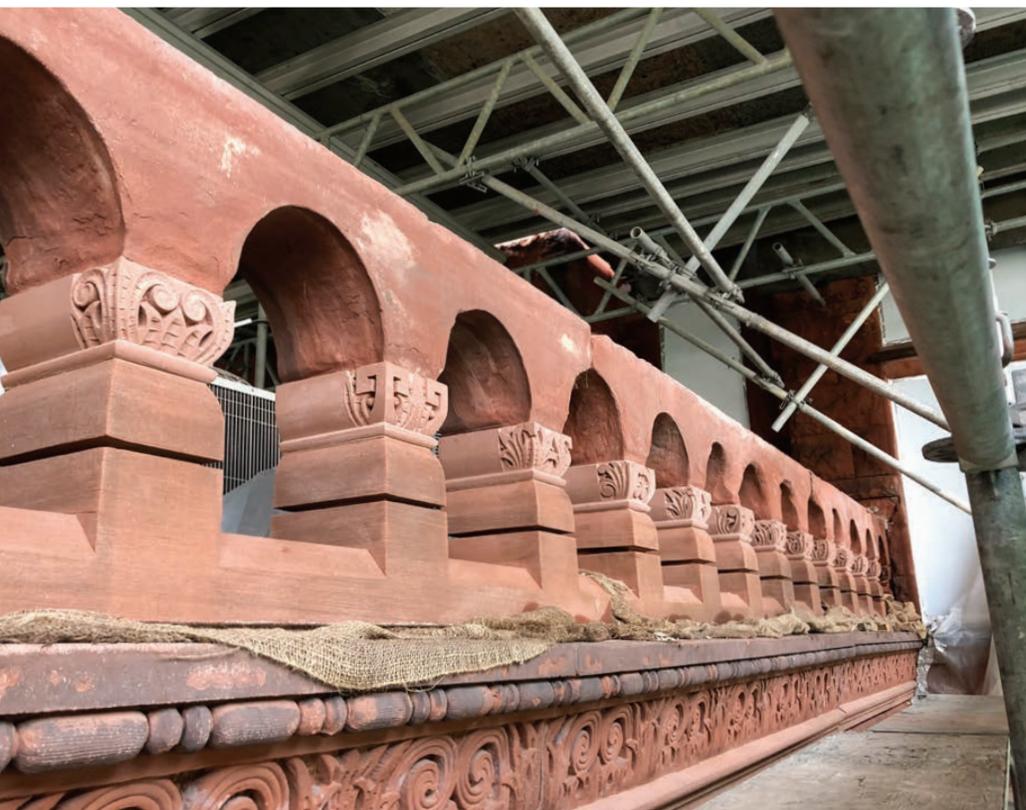
▲ The porte cochère restoration will be completed in 2018. Photo The York Club, 2018
